Title: *GEOCHEMICAL CHARACTERIZATION OF GEOLOGICALLY COMPLEX MOUNTAIN FRONT AQUIFERS: Placitas, New Mexico*

Author(s): William J. LeFevre

Publication Date: June 1999

Publisher: New Mexico Institute of Mining and Technology

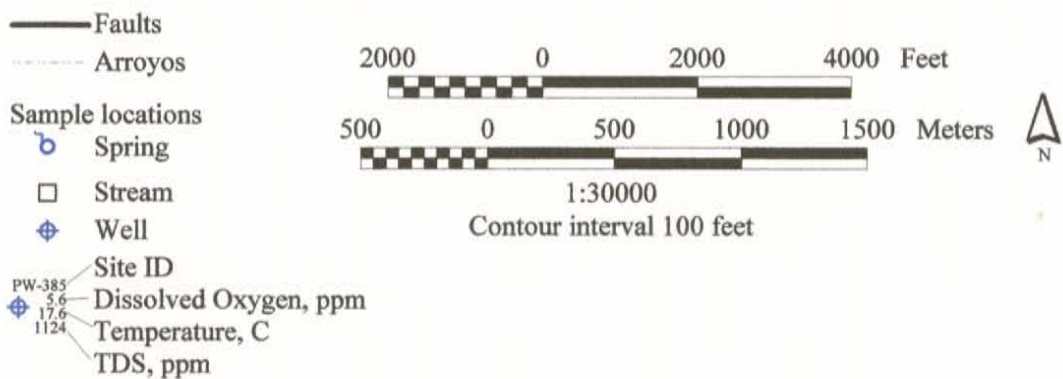
Figure 43. Location, temperature, dissolved oxygen concentration, and TDS concentration of ground-water samples collected from Cuchilla Lupe and upper Las Huertas Canyon.

- Figure 9. Potentiometric Surface (p. 92)
- Figure 42. Aquifer Sub Zones (p. 125)
- Figure 43. Location, temperature, dissolved oxygen concentration, and TDS concentration of ground-water samples collected from Cuchilla Lupe and Upper Las Huertas Canyon (p. 126)

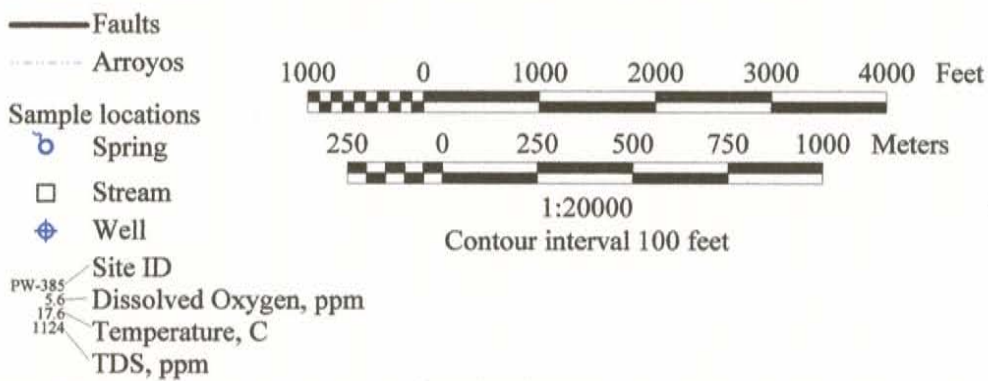
Figure 52. Location, temperature, dissolved oxygen concentration, and TDS concentration of ground-water samples collected from the central part of the Mesozoic ramp.

- Figure 52. Location, temperature, dissolved oxygen concentration, and TDS concentration of ground-water samples collected from the central part of the Mesozoic ramp (p. 135)

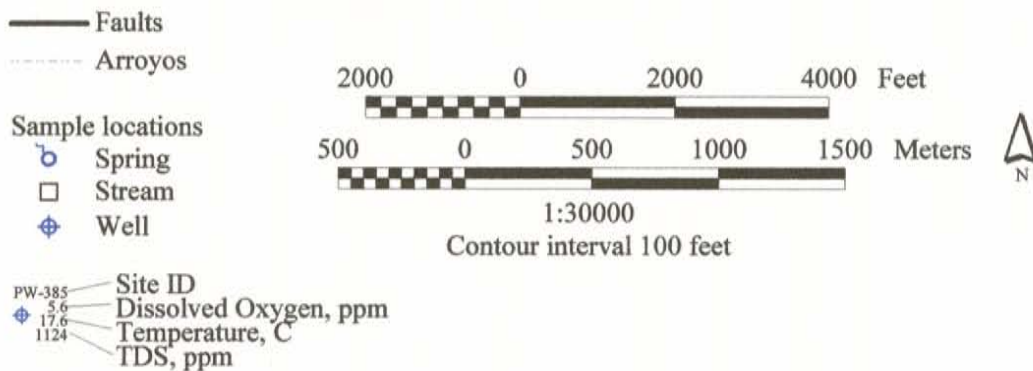
Figure 61. Location, temperature, dissolved oxygen concentration, and TDS concentration of ground-water samples collected from the western part of the Mesozoic ramp.

- Figure 61. Location, temperature, dissolved oxygen concentration, and TDS concentration of ground-water samples collected from the western part of the Mesozoic ramp (p. 144)
