**Title:** *UPDATE OF HYDROGEOLOGIC CONDITIONS AT THE DIAMOND TAIL SUBDIVISION, SANDOVAL COUNTY, NEW MEXICO*

**Author(s):** Roger L. Peery, Annie M. McCoy and Laura H. Petronis

**Publication Date:** August 2006

**Publisher:** John Shomaker & Associates, INC. (prepared for Diamond Tail Subdivision)

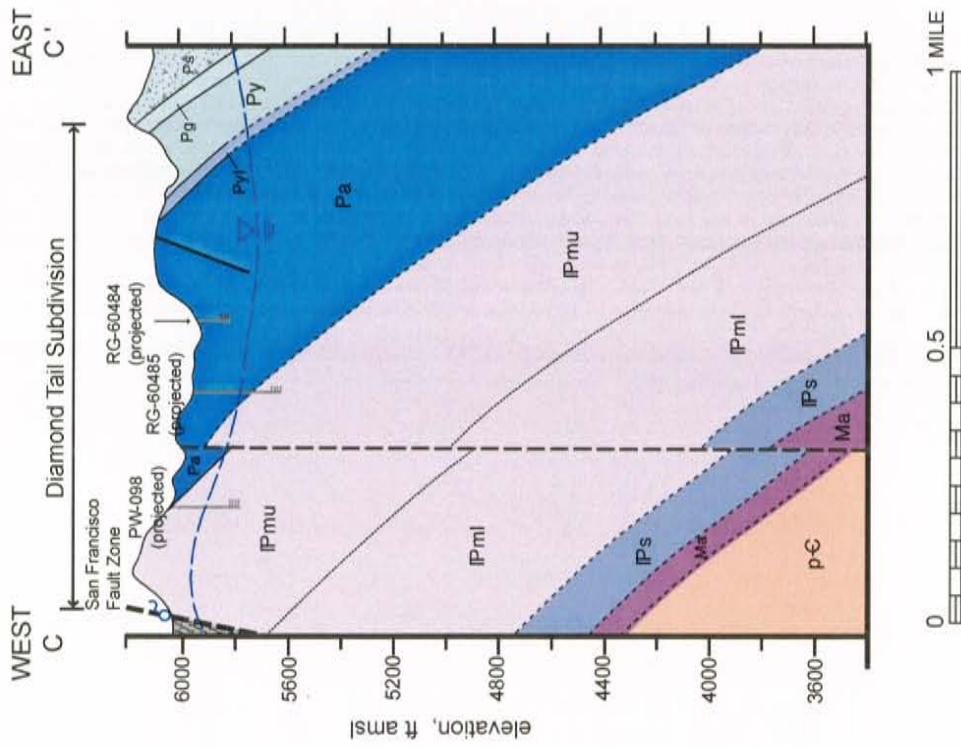
Figure 6. West-east geologic cross-section C-C' through Diamond Tail Subdivision, Sandoval County, New Mexico, modified from Johnson (2000).

- Figure 1. Map showing location of Diamond Tail Subdivision, Sandoval County, New Mexico.
- Figure 3. Geologic map after Connell (1999) showing Diamond Tail Subdivision and adjacent area.
- Figure 4-6. Geologic cross-sections for the Diamond Tail Subdivision modified from Johnson (2000).
- Figure 8. Topographic map showing ground-water elevation contours and flow direction at Diamond Tail Subdivision.
- Figure 9. Topographic map showing approximate depth-to-water contours at Diamond Tail Subdivision.
- Figure 14. Map showing minimum total saturated thickness of the aquifers beneath the Diamond Tail Subdivision.
- Figure 15. Map showing hydrogeologic areas and plat, Diamond Tail Subdivision.
- Table 3. Summary of pumping-test results for wells completed at the Diamond Tail Subdivision, Southern Sandoval County, New Mexico (p. 14)
